FIRES ON THE HOUSEHOLD LOW-VOLTAGE DISTRIBUTION BOARD CAUSED BY THE ABSENCE OF POLE MOUNTED FUSES AND SURGE ARRESTERS

Abstract: *This paper deals with the issue of the fire occurrence which is caused by low-voltage electrical installations (household distribution board) due to the absence of protective devices (fuses and surge arresters) on the pillars of the electrical distribution network. The example of calculation of fault currents is given, for the fault current on the basis of which it is proved the necessity of installing of pole mounted fuse on the latest pillar of low-voltage electrical distribution network. In the paper there are examples of fire expertise for fires caused by non-installation of pole mounted fuses and surge arresters are presented.*

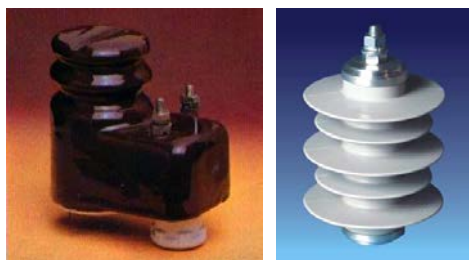
Figure 1. The appearance of pole mounted fuse (left) and surge arrester (right)

Surge arresters are devices that have non-linear resistors tied to the earth which while crossing of over-voltage reduce their resistance by leading some of the energy into the earth. With the disappearance of over-voltage they increase their resistance to the original value. Latest generations of surge arresters are divided into two groups according to their construction: silicon carbide (SiC) and metal oxide or zinc oxide (ZnO) surge arresters.

Figure 1 shows the external appearance of pole mounted fuse and surge arrester.

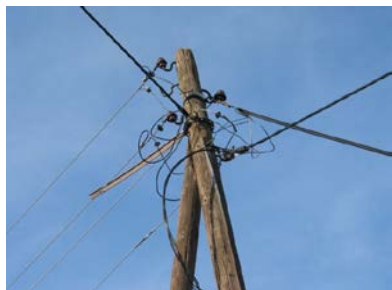
Figure 8. *The appearance of pillars from which the building is supplied with electric power*

From Figure 8 it can be clearly seen that the column does not have installed fuse, and also has no surge arresters, even though it is the last on the route.

The maximum allowed intensity of current of household cable conductors of the console to the distribution board (section of 4 mm²), demanded the installation of pole mounted fuses of 25 A. The absence of such pole mounted fuses in the present case makes installation of a household connection technically incorrect. Fuses at the excerpt of transformer station due to high values cannot protect household connection port from overload and short-circuit current, nor can the main fuses on the distribution board, because it is situated behind the installation of a household connection cable in the direction of transmission of electricity.

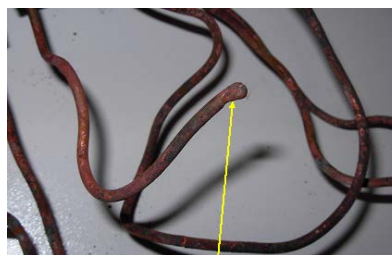
Figure 9. *The copper conductor in which there is visible trace of melting as a result of the high temperature of electric arc*

Copper beads as result of the melting of copper are formed at temperatures higher than 1083°C (the melting point of copper). When a short circuit - the arc of electricity causes the fire (the primary short-circuit), there are occurrence of considerably higher temperatures with formation of beads, and/or welds. There is also possibility of interruptions of the conductor due to the falling of molten copper. Secondary short circuit could be occurred on electrical installations as a result of the transferred fire that damages the insulation of conductors, causing a new arc. The metal structure testing of welds and beads, conducted by methods based on the presence of oxygen at the place and at the moment of short circuit, gave the final confirmation. With the primary short circuit there is great oxygen presence, and very little in the secondary short circuit, thus causing differences in the structure of the place cheeks (Figure 9).

The appearance of two welt beads in a locus indicates to the existence of the electrical arc when developing very high temperatures, so this locus can certainly be place of fire, i.e. place of the primary short-circuit. This may, if necessary, further be confirmed by the metallographic examinations of welds on the conductor using the method of light microscopy, followed by a definitive confirmation by the method of X-ray analysis.

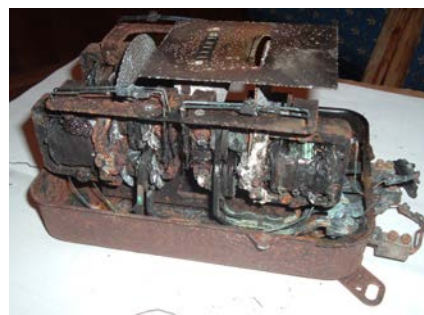
Figure 10. *The appearance of the inside of a burnt-out electricity meter*

All material evidence indicate that the initial cause of the fire is the damage to the electricity meter contacts (Figure 10) and conductor insulation of household connection cable with cumulative function of earlier surges of atmospheric origin, the consequences of which are not suppressed in the absence of protective measures (pole mounted fuse and surge arrester). It is particularly significant that this damage may have a gradual development - partly damaged insulation, followed by a small fault currents due to the ever-present voltage in electric network, that increases over time and causes overheating, which cannot be protected by fuses that are not well dimensioned or do not exist in the observed part of the installation.
